CASE STUDY

# Local Farmer from Shropshire - Pow-R Wrap

**Objective:** Provide a retro-fit seal solution for a leaking high pressure connection to a water silo.

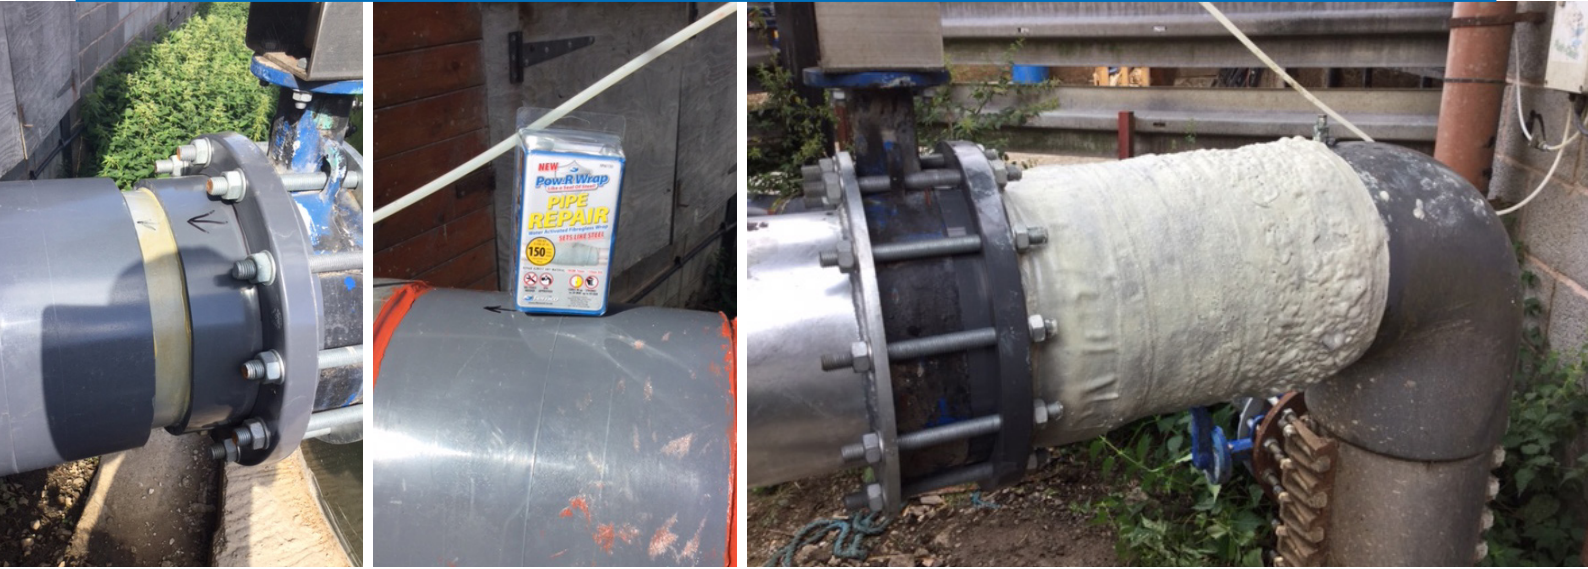
A farmer from Shropshire had a leaking inlet/outlet on his water silo, used to wash out cattle sheds.

The problem connection, needed a retro-fit solution which could be wrapped around the pipe to stop the leak.

Fernco stock a range of fibreglass repair products, Pow-R Wrap. The product comprises of an epoxy putty and resin impregnated fibreglass sheet which sets extremely strong, up to 40 bar of pressure.

The contractor was able to fit the product without the need for any tools, just using the components provided in the Pow-R Wrap pack.

The wrap cured in 30 minutes, after which the seal was tested and subsequently passed and the contractor was able to sand the material and paint over it.
